# Restoration of Meanders on the Dyje/Thaya River

David Veselý

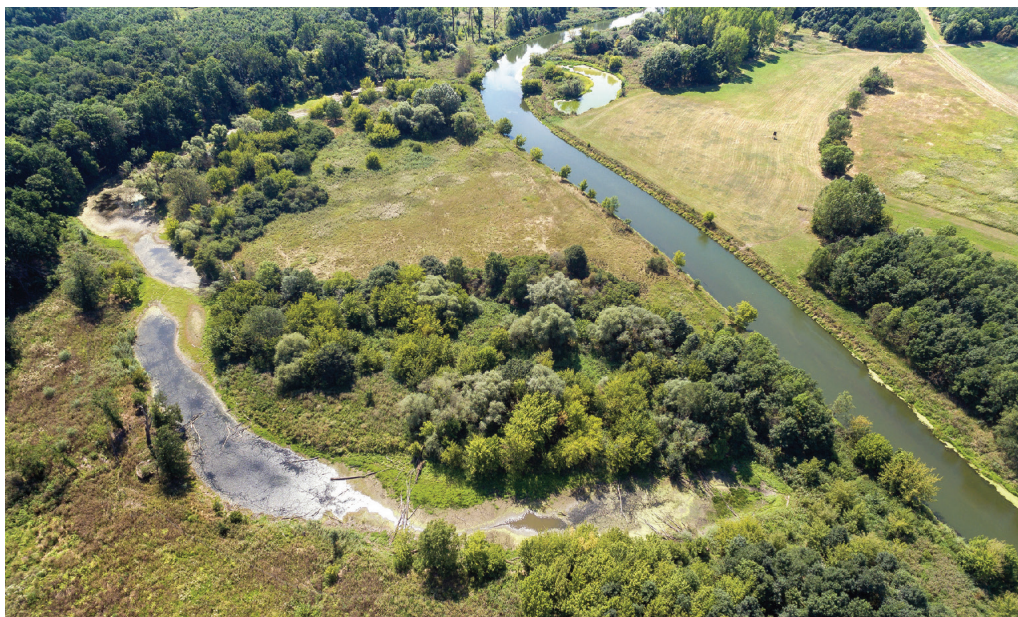
The state of play before implementing the measures, vanishing river arm D9, Morava River Basin Management Authority © Vladimír Husák

In the first stage, two arms were connected to the river, D18 on Austrian territory and D9 on Czech Republic's territory. The two arms were connected according to the same principles in both the countries. By full connection we mean 'ecological integration', i.e. the opening of both ends of the arm and inserting a dividing object into the original puncture. In addition, the small D8 arm, which forms a joint unit with the Czech D9 arm, was connected unilaterally on the Austrian side. Besides the connection of these arms, the project included the creation of a wetland communicating with the river at increased flow rates, and the formation of terrain elevations from excess soil.

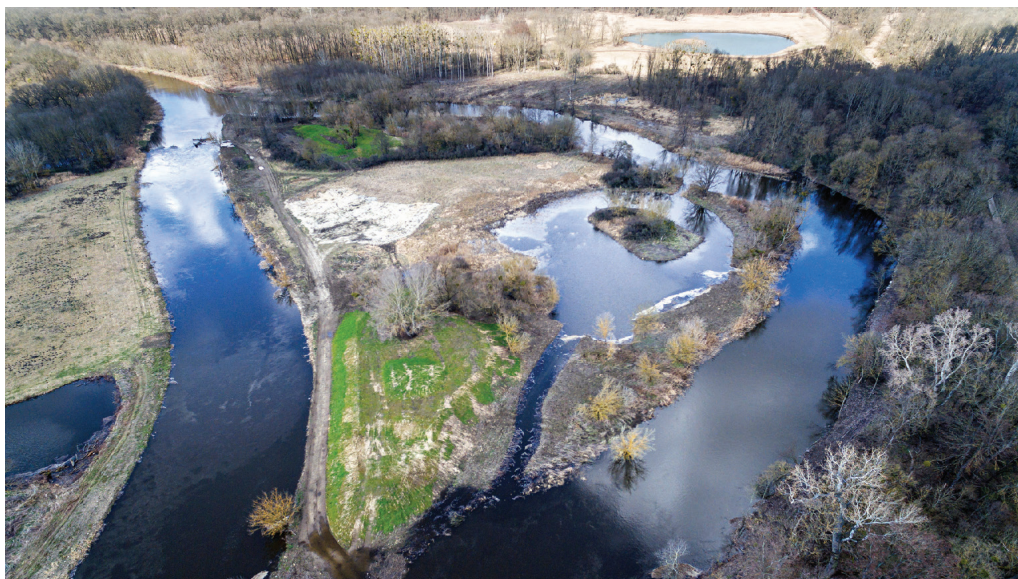
Increased flow rates, reconnected river arm D9, Morava River Basin Management Authority © Vladimír Husák

Already during the construction work, shortly after the first arm was connected, and subsequently after the entire first stage was completed, the Dyje/Thaya River was faced with two spring floods. The response of the morphological processes not only in the reconnected arms, but also in the original puncture, was unexpectedly positive. The river willingly accepted the new patterns, and morphological structures absent in that river section until then were formed in the riverbed. Gravel banks and alternating depths and shallows in fords now add to the character of the lowland river. The story was repeated during the second stage. Neither then did the river want to stay behind, and also in spring in 2023, the newly connected arms were faced with a two-year flood. We have not been able to survey the river before completion of this article in order to see how the extreme flow rate has affected the river morphology. However, it is clear from aerial photographs that the facilities fulfilled their function just exemplarily. We are looking forward to seeing which new morphological structures the flooded river has left behind.

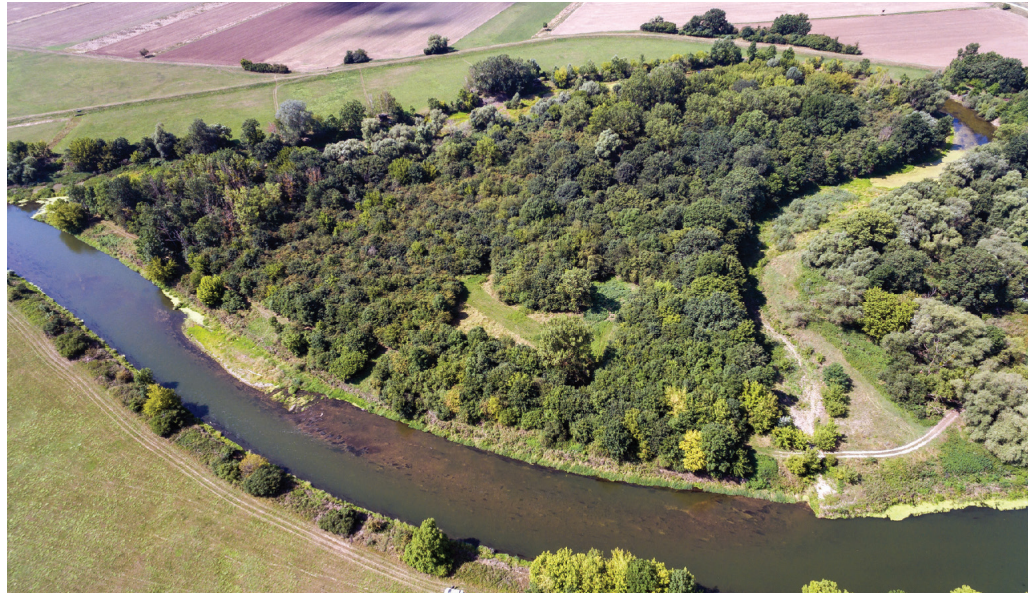
The state of paly before implementing the measures, silted river arm D18, Morava River Basin Management Authority © Vladimír Husák

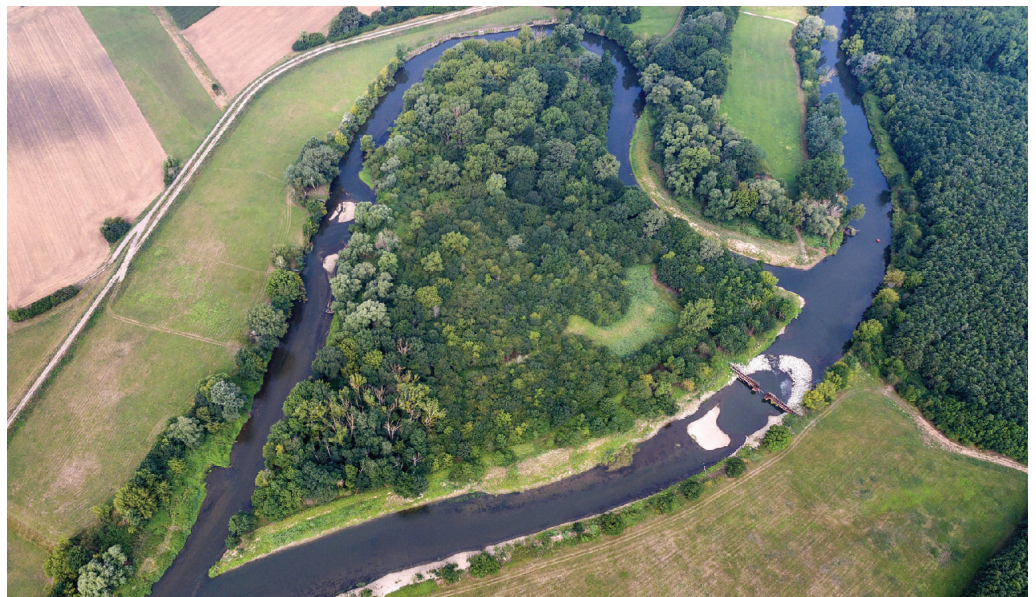
New Dyje/Thaya River arm D18, Morava River Basin Management Authority © Vladimír Husák

Thanks to the connection of the longest oxbow on the Austrian side – meanders D18 and D9 on the Czech side – the Dyje/Thaya River course has been extended by more than 1.5 kilometre. The arms D1, D2, D5, and D12 added almost
