# Water Retention in Urban Agglomerations

Jiří Karnecki

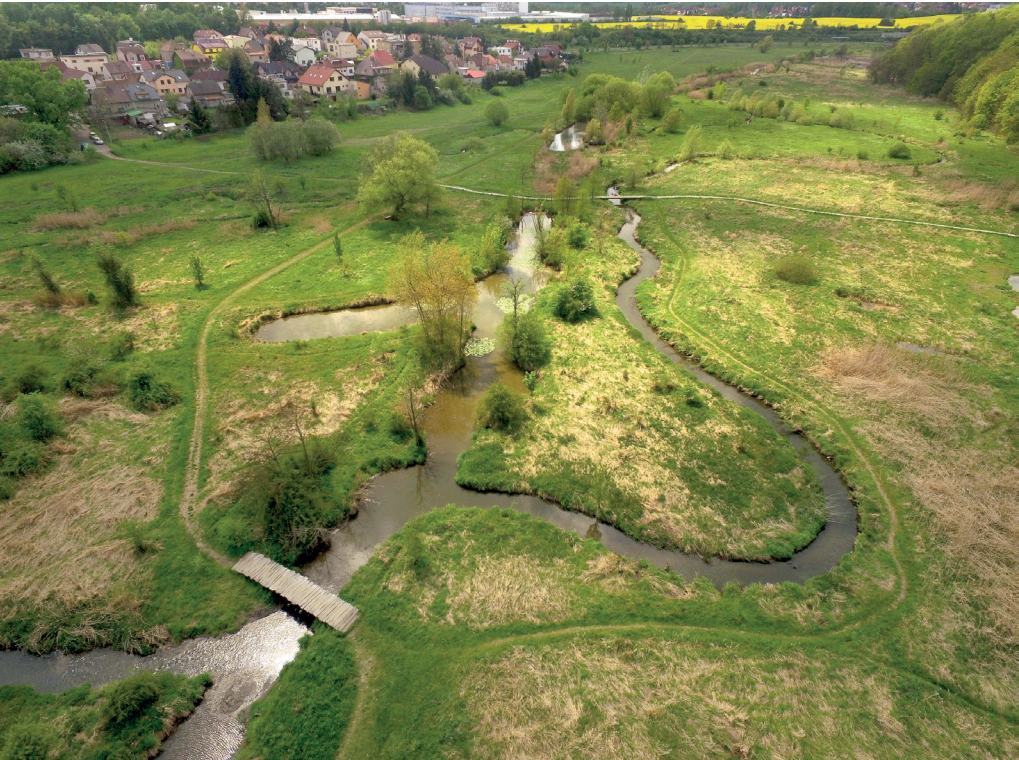
The Čihadla dry polder restoration. ©Jiří Karnecki

To avoid mistakes made by the predecessors proposing indiscussable projects, the team first of all selected a suitable area/site owned by the Capital City of Prague which could be relatively easily restored. The Čihadla dry polder covering 19 hectares where three brooks, namely the Rokytka, Hostavice and Svěpravice ones, were straightened and channelized in the 1980s seemed to be ideal. The project documentation was elaborated by the Ekotechnik Inženýring Company Ltd. and in 2008, the building was made with support from the European Union's funds. The finished building has been appreciated by the general public and experts, presented on some expert conferences and workshops and visited by many excursions. Just as a matter of interest, the project has been living and in addition to building new pools for amphibians every year, other three small water reservoirs have been established there, the Svěpravice Brook restoration has been prolonged, inert waste made-up ground with a dog-training grounds was eradicated and nature-based management on meadows including cattle grazing has been introduced there.

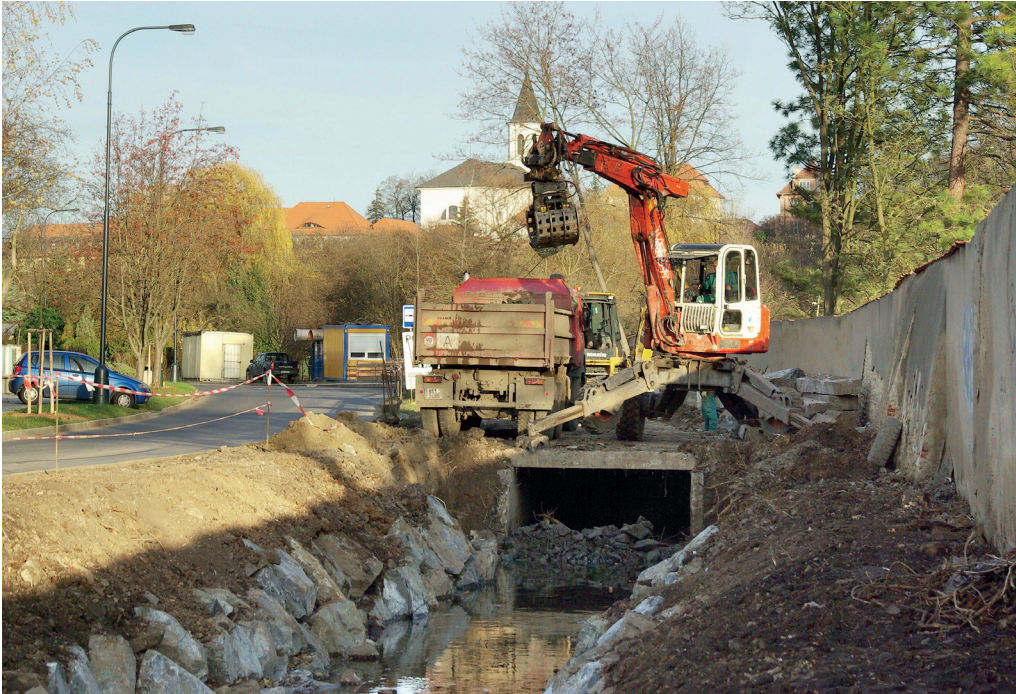
Launching the Litovice-Šárka Brook near the Hvězda/Star game-keeping preserve. ©Jiří Karnecki

The other important project was opening the arched Litovice-Šárka Brook bed along the Hvězda/Star game-keeping preserve in 2010. The brook was arched in relation to building the Džbán/Jug water

reservoir used for recreation. The reason officially presented for the bottomless arch culvert was improving water quality and elimination of contamination/pollution sources. It was just one of the fragments from the project commissioned as early as in the 1990s which had been negotiated

more than ten years. For the first time in Prague, heavy stone-packing from boulders weighing up to 500 kilograms was applied there. Therefore, just shortly before starting the project, there was an indignation levelled against the project among local people. Finally, they were

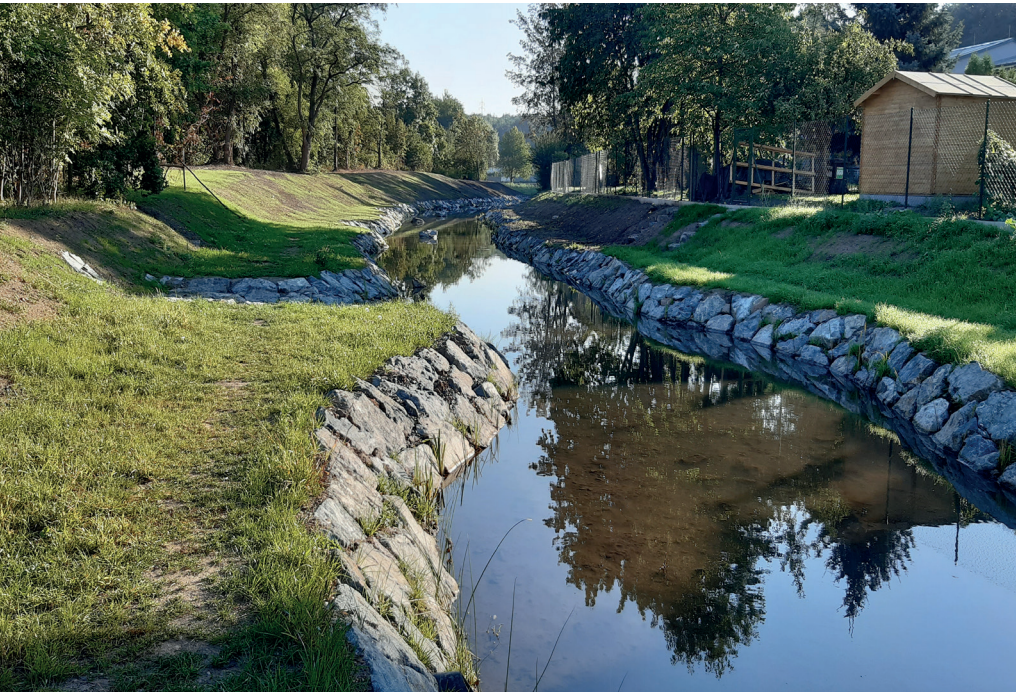
The Rokytka Brook restoration below the Čihadla site. ©Jiří Karnecki

Extensive restoration of the Rokytka Brook from the Kyje to Vysočany city quarters just displays a natural classroom of water ecosystem restoration. On the five-kilometre-long stretch, bringing a meandering brook back into a floodplain meadow, stretches reinforced by stone-packing, one-side broadening of the bed, boulder slides, stone built-ins to split the bed, dead wood application, pools and walls for kingfishers can be seen. The last addition is an increasing in the Rokytka Brook capacity in the Kyje city quarter where a part of land plots had been purchased from private owners and an ecological narrow terrace up to 10 meters wide for directing flood flows was built. The Rokytka Brook itself was divided and stabilized by the stone-packing.

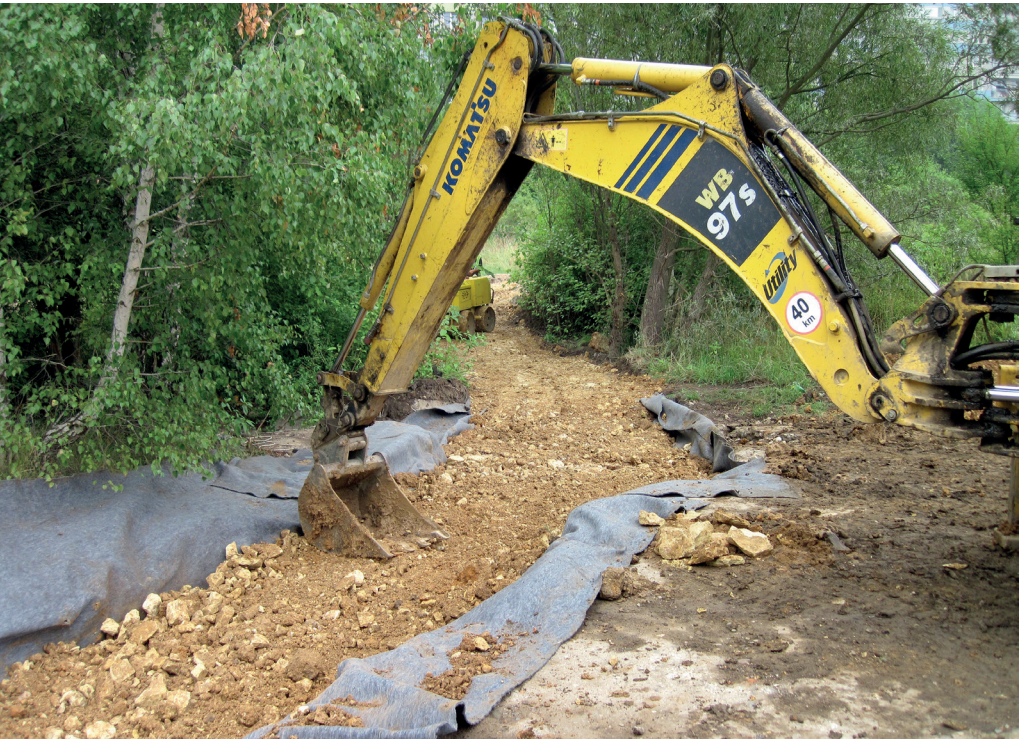
Building the Řepy Brook bed.  
© Jiří Karnecki

Within the Brooks for Life project, attention was paid to the Řepy Brooks. In the 1950s, there had still been some fishponds fed by the Řepy Brook in the Řepy city quarter. Due to building development, fishponds were step-by-step conversed and the brook itself vanished. Therefore, the only fishpond called Prasečák/Hog Pen and a small part of the brook's dried bed near the fishpond remembering that once there was a brook there left by the 21<sup>st</sup> century there.

Efforts to bring the brook back dated back to the 1990s and among Prague watercourse restorations, this is the most lasting one. In 2014, the last acceptances had been finally gained and the project's implementation could begin. The adjacent Hliník Lake has become a water source. Getting over a railroad and a road by controlled boreholes below them was a piece of cake compared to building a new open bed. The project clearly demonstrated the difficulties related to building a new brook in an urban area. Below approx. 0.5 m soil layer a concrete slab had been found: thus, building a new bed resembled more building a pavement than a brook. Therefore, the concrete slab had to be put away and an excavation was filled by clayey soil; only in such prepared corridor a new bed of the Řepy Brook could be ditched. Now, the area has become overgrown by vegetation, refreshing the nearby Řepy housing estate.

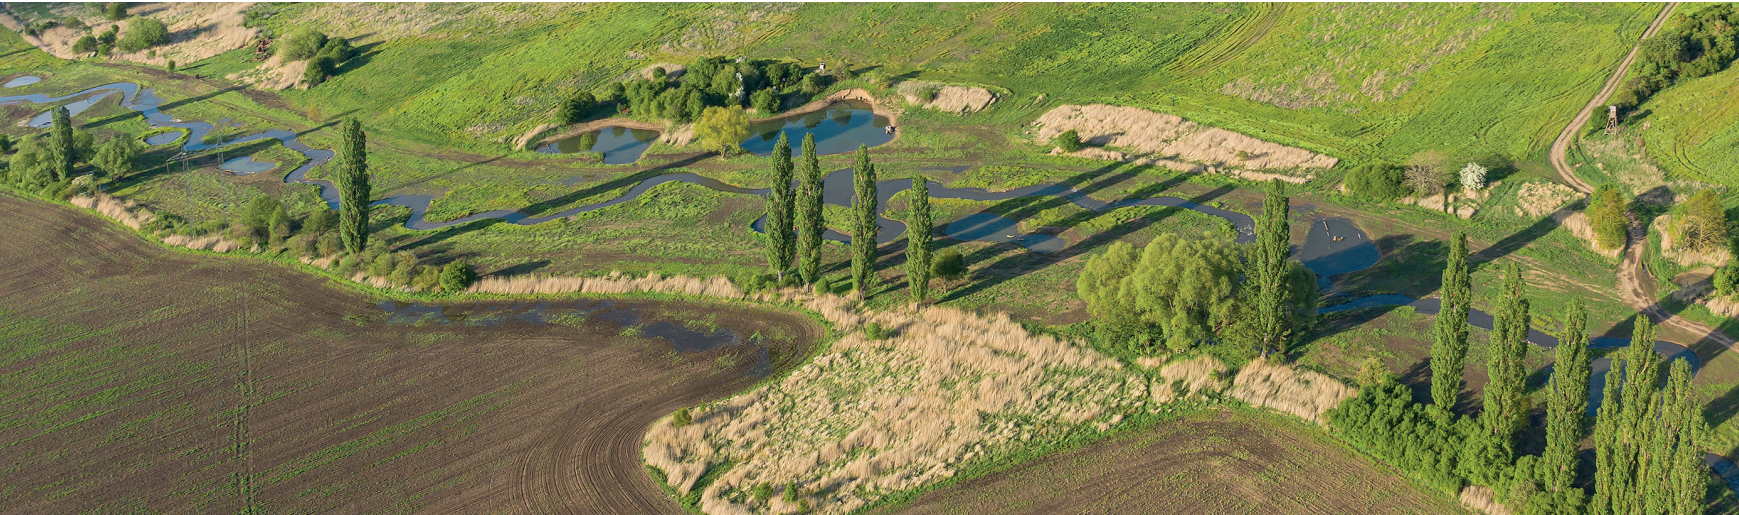
The Říčanka Brook and its floodplain below the Litožnice Fishpond.  
© Jiří Karnecki

Within the *Landscaping the confluence of the Rokytka and Říčanka Brooks* project, the whole Říčanka stretch on the lands owned by the Capital City of Prague was proposed to be restored. The brook near a fishpond left its original bed and for the restoration, the whole brook's floodplain was used. The length of the new bed accounts for 1,075 and the brook was lengthened by 300 meters. The new meandering bed was supplemented by a set of larger and smaller pools in total covering 5,980 m<sup>2</sup> and retaining 2,169 m<sup>3</sup> of water. In a pool, a bank was shaped so that a vertical wall for kingfishers was created. Wade stretches were stabilized by a stone riprap and trees which had had to be fallen down were used as dead wood both in the brook and the pools. The original brook bed was – except one site where a pool was created – filled. Because the floodplain had been in the past used as arable land, the whole area was sown by a grass mixtu-

re of herb-rich meadows. Two wades from stone-packing and two ceiling pedestrian bridges were also built there.

In this case, the author had a fiddle with numbers. In addition to making the brook bed longer and creating a system of pools, he compared the water volume in the original bed during an ordinary flow and that in the restored bed. In the latter, 2.5 times more water than in the former is captured. Thus, this is a clear indicator on necessity and suitability of water ecosystem restoration projects.
