Assessing Clogging the Dobroměřice Fishpond by Sediments

Josef Krása, Tomáš Dostál, Miroslav Bauer

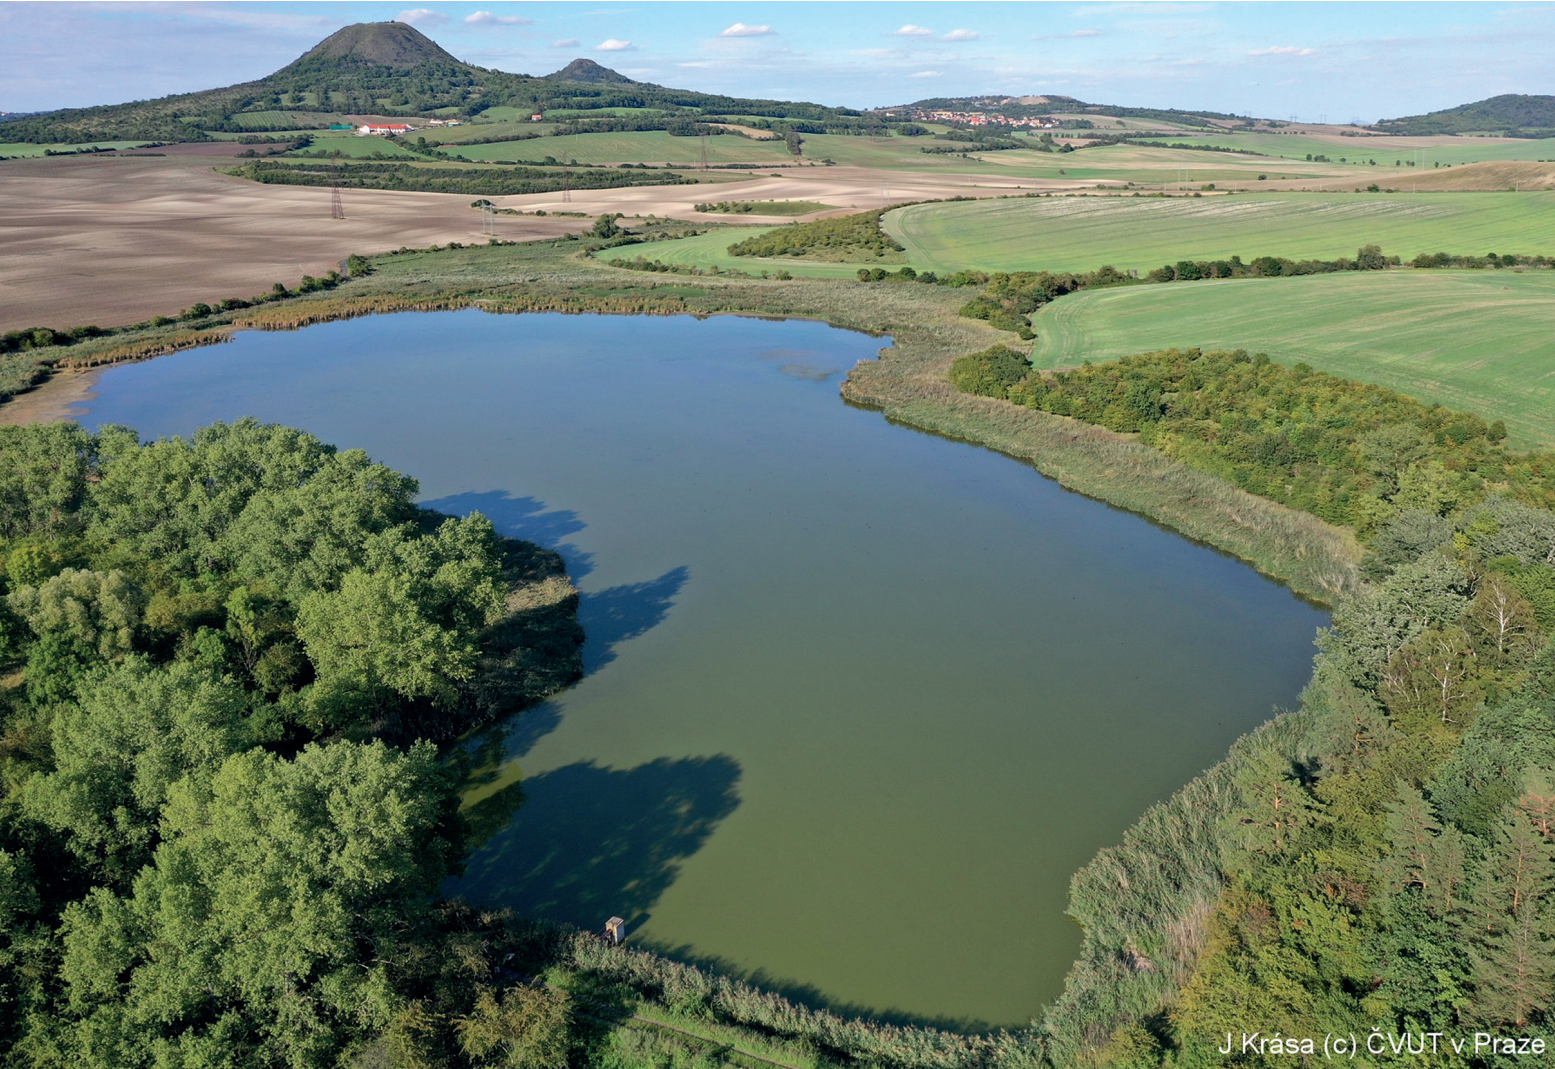
Figure 1: The Dobroměřice Fishpondand its catchment area with Oblík Hill (509 m a.s.l.) on the horizon. © Josef Krása

The Dobroměřice Fishond (Fig. 1) is a unique water body with extensive littoral vegetation within the dry steppe part of the Lounské středohoří/Louny Uplands. In terms of aquatic and semi-aquatic vertebrates, it is one of the most valuable areas in the whole České středohoří/Bohemian Uplands Protected Landscape Area (PLA). In addition, it is a very important nesting site for waterfowl, with a number of rare species associated with riparian areas with shallow submerged vegetation offering sufficient food and nesting availability. It is an equally important site as a stopover during spring and autumn migration for birds (long-term capture site), again mainly due to its location and the absence of similar sites in the wider region.

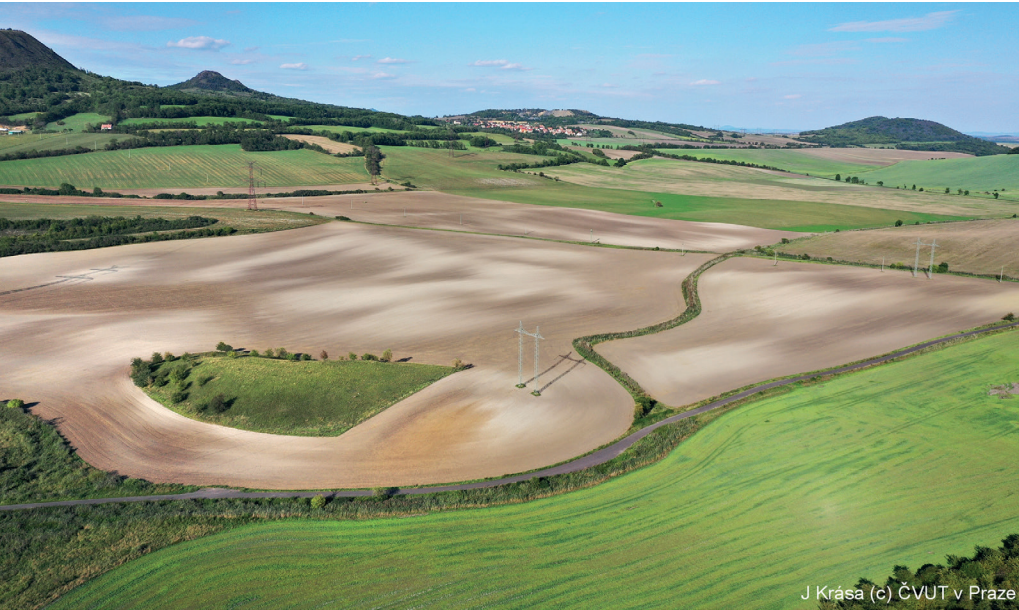
Figure 3: The north-east part of the catchment area, washed-out soils and the character of the tributary bed. © Josef Krása

Although these are not particularly steep areas, the manifestations of excessive erosion processes and subsequent damaged and washed away soils are clearly visible from aerial photographs (Fig. 3). The vast majority of soils in the Dobroměřice Fishpond catchment area can be characterized as non-structural, fine-grained, and not very cohesive. Such soils are difficult to cultivate, but very fertile for agricultural production. However, from an erosion point of view, it is a very dangerous material because such soils usually have very low permeability, but at the same time they are easily leached.

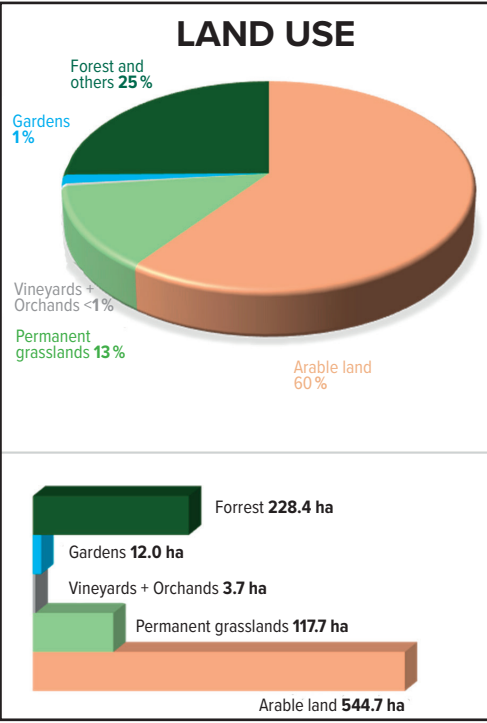
Figure 2: Proportion of the main land-use categories

As far as agricultural land is concerned, arable land currently (2019) covers 544.65 ha (80% of Agricultural Land Resources) and consists of 65 plots, according to the Land Parcel Information System (LPIS) records. Permanent grasslands occupy 117.7 ha, vineyards 2.12 ha, orchards 1.62 ha, and there are about 12 ha of gardens around the built-up area (Fig. 2).

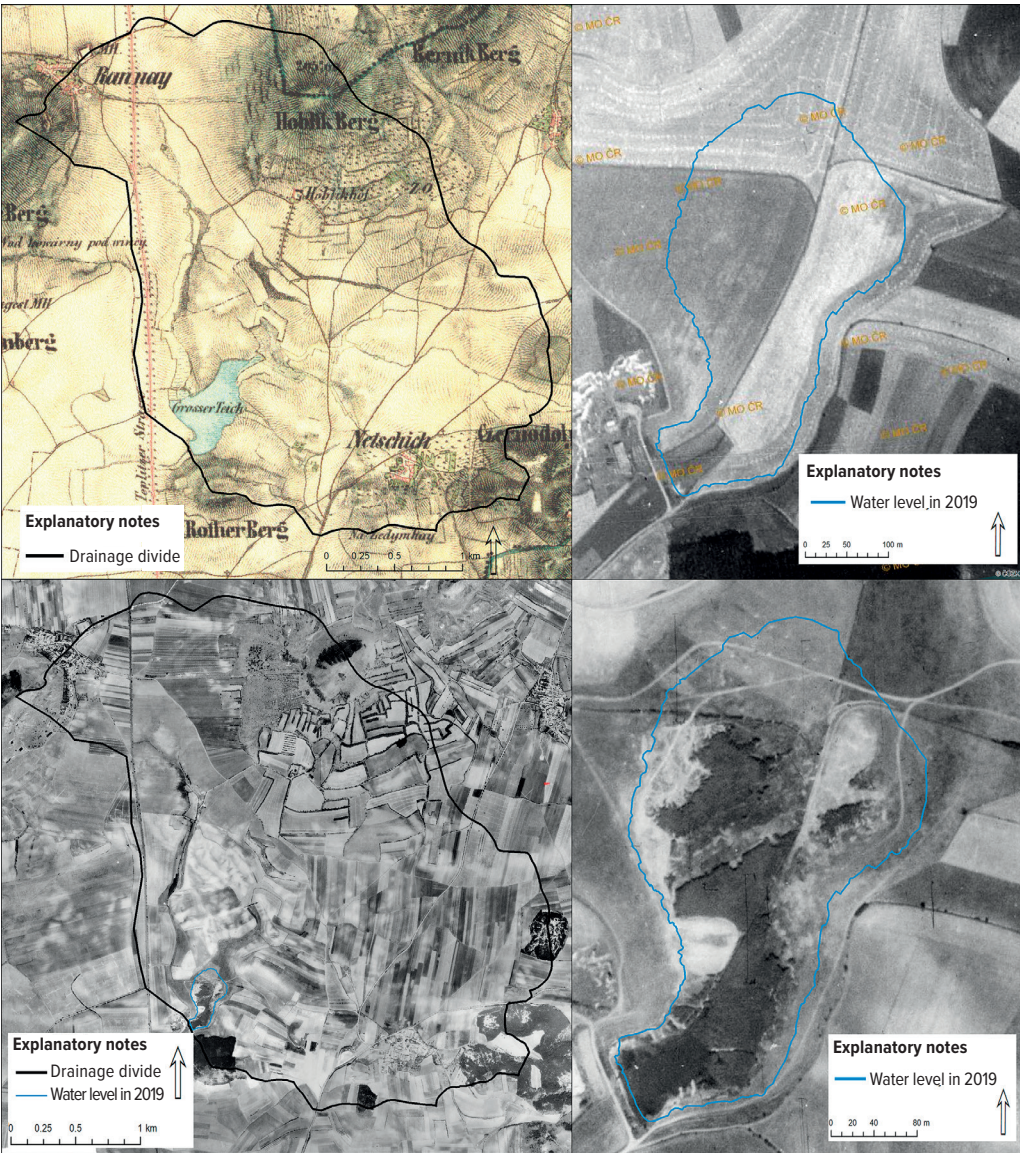
Figure 4: Historical photographs – 1840 (upper left); 1938 (upper right), 1952 (bottom left and right). Photo background data by CENIA and the national archive of aerial survey photographs, State Administration of Land Surveying and Cadastre (SALSC), compiled by Josef Krása

The situation around the development of Dobroměřice Fishpond itself is surprisingly dynamic. As documented by the historical maps and aerial photographs below (Fig. 4), the fishpond had been there at least before 1850 (in approx. its current dimensions). However, 1937 images show that the floodplain was drained and the area was used as agricultural land. Soon after that (documented by a picture from 1952), the area was re-wetted and economic use limited or even excluded – the area is wet and lying fallow.

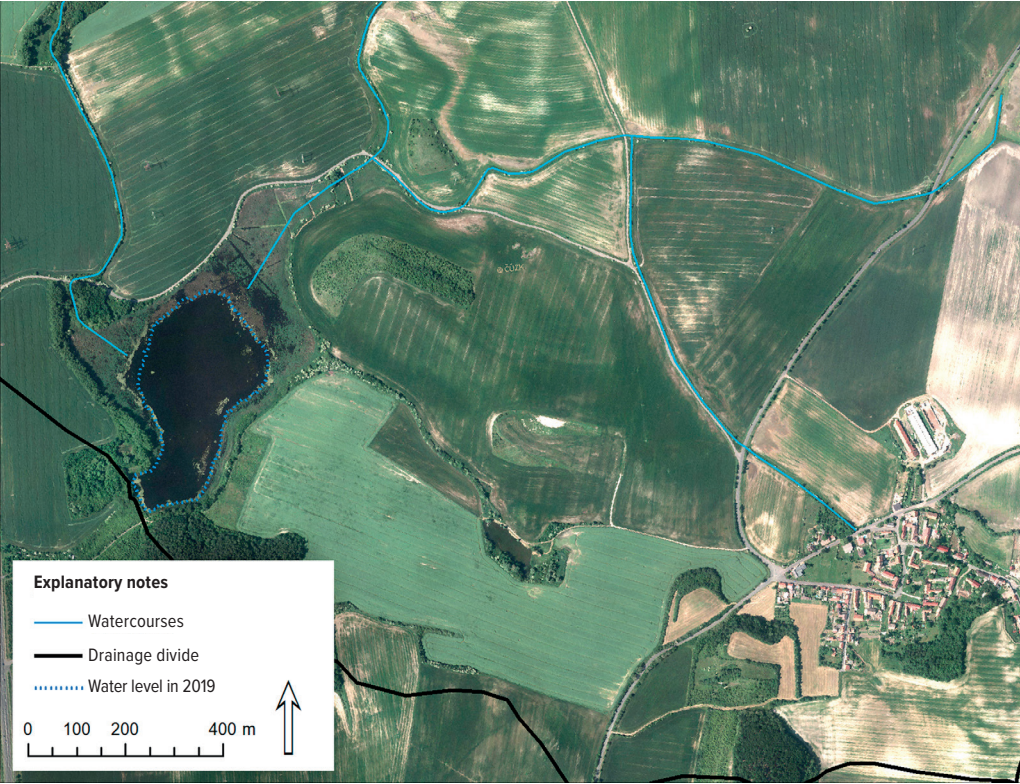
Figure 5: State of the catchment area in 2013 (archive orthophoto © SALSC)

No direct traces documenting the current erosion or transport and deposition of erosive alluvium were found by field survey; however, long-term erosive damage to agricultural soils is clearly documented by aerial photographs – see e.g. Figure 5.
